PROJECT EXPERIENCE PROFILE

Shower Malfunction in New Apartment

Motorists Insurance Company

Columbus, Ohio

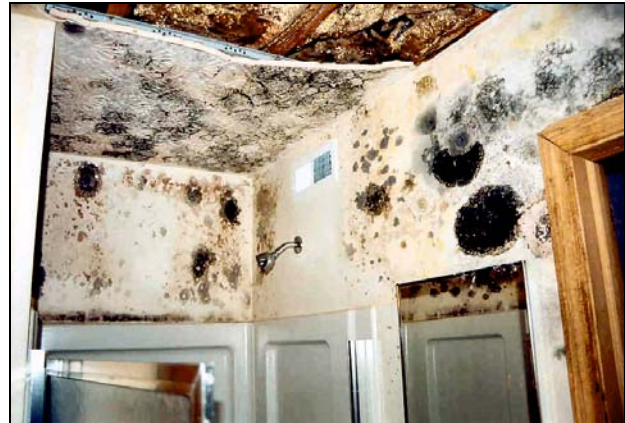
The CTL Engineering investigation revealed that the plumbing contractor did not properly install the shower control handle. The temperature control safety feature was not set but this should not have caused the shower to turn on by itself. The cause of the problem was finally revealed when the showerhead was removed and examined. The plastic screen inside the showerhead was plugged by debris from the installation of the plumbing lines (i.e., metal and plastic turnings, dirt, solder, etc.). The plugged screen had broken, allowing water to flow through the showerhead.

It was concluded that the plumber had probably turned the shower on to flush the lines and adjust the temperature control on the handle. The screen in the showerhead became blocked, stopping water flow. The plumber apparently forgot the shower handle was still in the on position and never finished the installation and adjustments. Later, the constant water pressure in the showerhead broke the plastic screen, allowing water to flow again.
